MISCELLANEOUS PAPER S-73-46

CONDITION SURVEY, PLATTSBURGH AIR FORCE BASE, NEW YORK

June 1973

Conducted by U. S. Army Engineer Waterways Experiment Station
Soils and Pavements Laboratory
Vicksburg, Mississippi

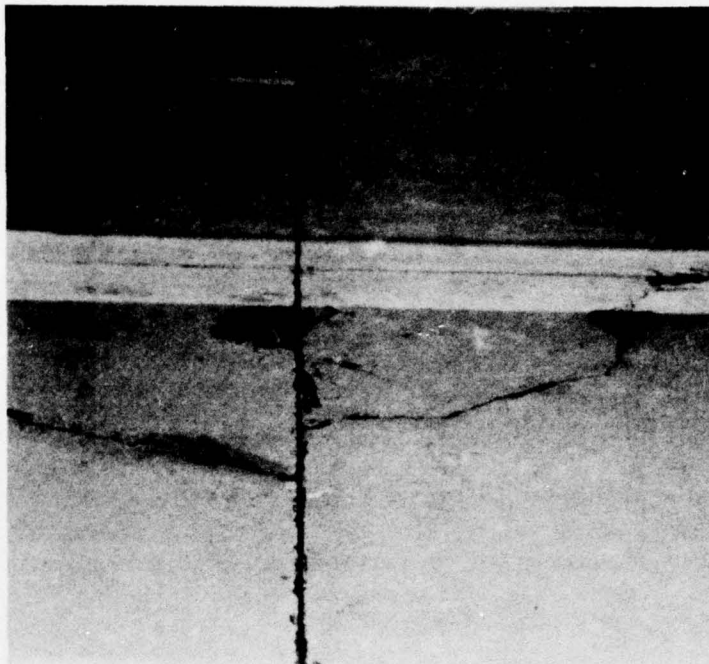
11. The first 1000 ft of the SE (35) end of the runway (features R1A and R2B) was in excellent condition, with only two major defects noted. Features R5A and R4B, the first 1000 ft of the NW (17) end, were in very good condition. Twelve major defects were noted in these features, nine of which were diagonal cracks, with seven of these being in the two center lanes. The interior portion of the runway (feature R3C), which had a total of 56 major defects (47 of which were in the center 120 ft), was in excellent condition. Photo 1 shows diagonal cracks in four slabs in the center of the runway, approximately 6000 ft from the SE end.

Photo 1. Diagonal cracks in four slabs in center of runway, approximately 6000 ft from SE end

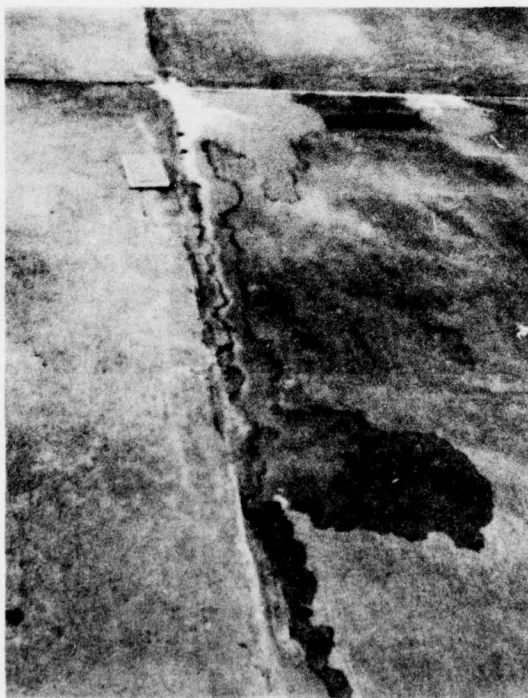
200 by 500 ft in which a large percentage of the slabs were discolored from the effects of water rising through the slab joints. Even though water was standing on the surface of some of this area, the survey revealed no abnormal number of defects for this area as compared with the number of defects in areas where there was no evidence of water. The north warm-up apron (feature A2B) contained 27 major defects, 11 of which were in the outer lane. This feature was in very good condition. The south warm-up apron (feature A3B) was in very good condition, with approximately 15 percent of the slabs containing either major or minor defects.

groundwater may be located at or near the pavement surface. Evidence of high groundwater was noted at the SE end of the parking apron where water was bleeding from some of the joints (photo 2) and in the shoulder of the south warm-up apron where water was bleeding from around a light base (photo 3).

Photo 2. Water bleeding from joints in SE end of parking apron

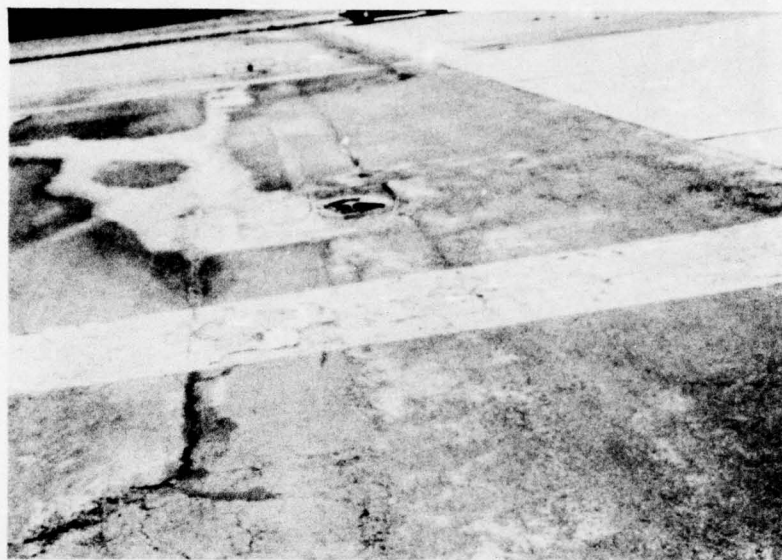
Photo 3. Water bleeding from around light base in shoulder of south warm-up apron

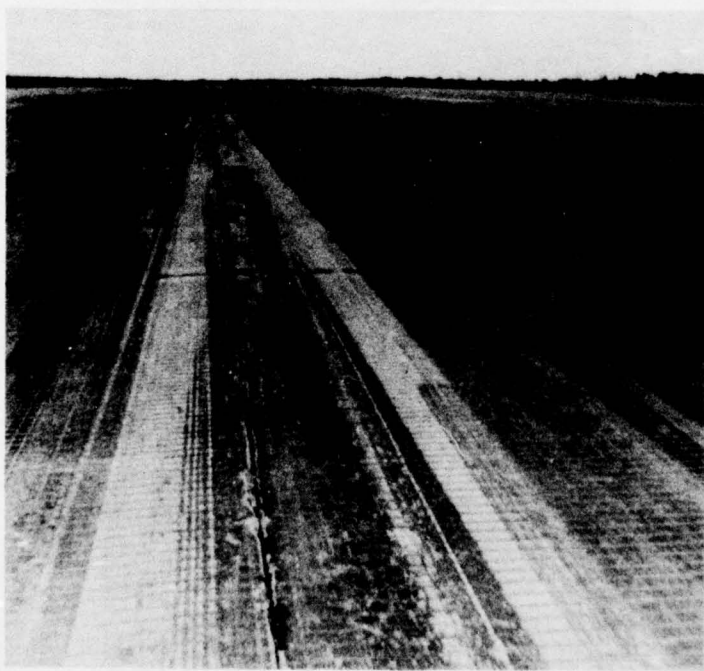
During the time of this survey, a spall repair program was in progress. In addition, the runway was being grooved for a distance of 70 ft either side of the center line to create a more skid resistant surface and alleviate the danger of hydroplaning. The joints on the runway were to be sealed at the conclusion of the grooving operation. Photos 4 and 5 show views of the grooved pavements.

Photo 4. View of grooved pavement looking down runway

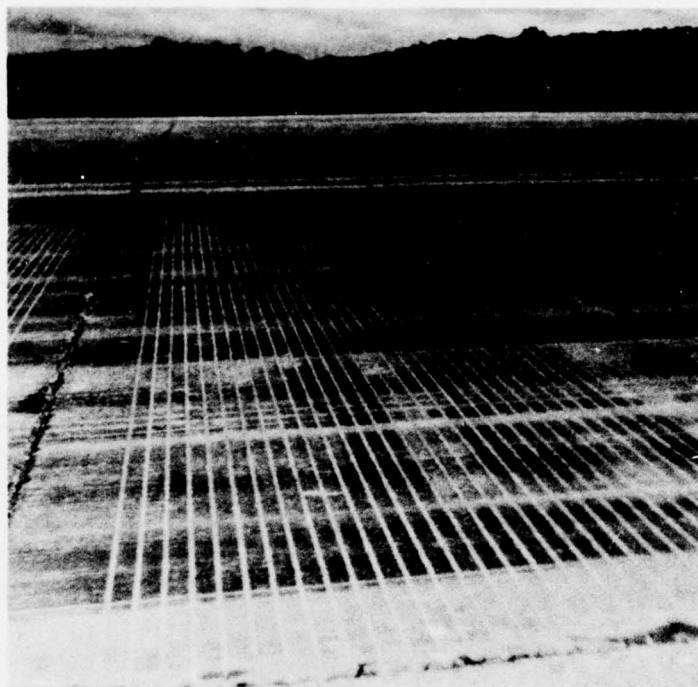
Photo 5. View of grooved pavement
looking across runway
